CITY OF BROOKINGS | 2021 BRIDGE INSPECTIONS

NOVEMBER 23, 2021

CHRIS BROZIK, PE
CIVIL DESIGN INC.
cbrozik@civildes.com

BRIDGE SAFETY INSPECTION REPORT

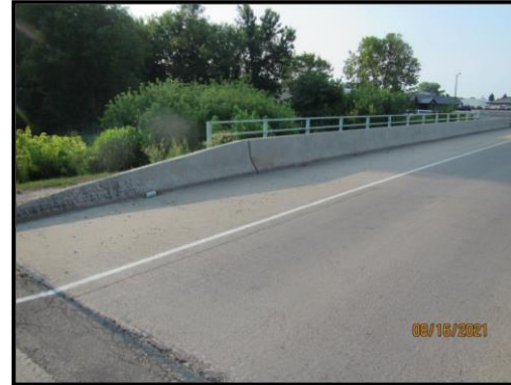
06-160-158_2021_13_CDI_East Bridge Barrier Rail

Cast-in-Place concrete barrier curb - there is vertical hairline cracking, scrapes and chips removed from barrier throughout. Scrapes and scaling are mostly observed along the curb line from snow removal equipment. There is isolated concrete spalling on the front face of barrier curbs. There are moderate vertical cracks evident over the bents on each barrier curb with crack spacing at approximately 6-10 inches o.c. and crack gaps of 0.02 inches on average. There is a moderate diagonal crack at the ends of the barrier curb at the NW, SW and SE ends.

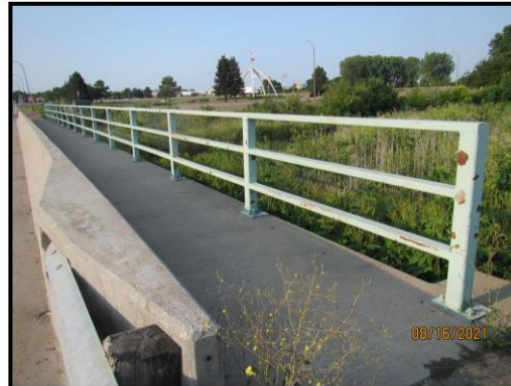
06-160-158_2021_14_CDI_West Pedestrian Steel Tube Rail

There are pedestrian steel tube railings along the concrete sidewalk on both sides of the structure. The railing is secure and functioning as intended. The paint is showing signs of weathering with cracking and peeling and flaked rust throughout. Some areas are beginning to have moderate sections of paint loss with heavy rusting with no section loss. Paint loss is estimated at approximately 15%. East pedestrian rail post #4 is bulging at base.

1. Remove debris from under structure (bike, branches, concrete rubble, and old concrete structure).
2. Remove tree growth under all four (4) corners of the structure.
3. Clean & Repaint sidewalk steel tube railings.
