City of Brookings

# Larson Ice Center – Ice System Replacement

Feasibility Report

November 19, 2018

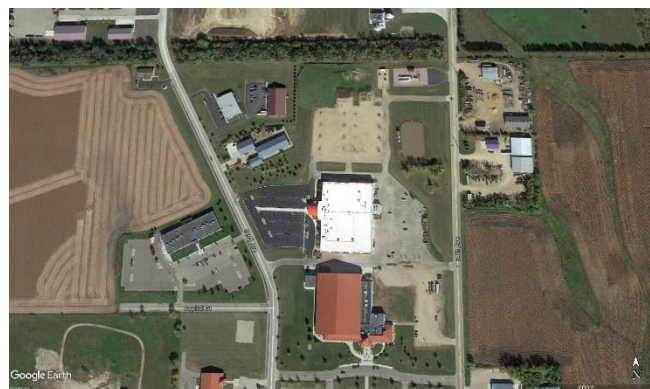
The site drainage system consists of 5 inlets on the north, west and south parking lots and roadways. The east parking lot appears to surface drain to the east and eventually into a ditch adjacent to 34<sup>th</sup> Avenue. As indicated in the CIMCO report there appears to be site drainage issues that may be adding to the wet subsoil conditions around the building. Upon review of the original Geotechnical Exploration Program from May of 2000, only 1 of the 13 borings indicated any presence of water. Because groundwater is seasonal it is difficult to assume that it did not exist at the time of construction, but given that there was no water observed to 16'-0" below grade in the original borings it is safe to assume that the wet subsoil conditions appearing today are a result of increased groundwater, poor surface drainage and additional development that has occurred in the area.

In addition to the site drainage issues it was also observed that there are roof downspouts draining directly to grade and adjacent to the foundation. According to the original drawings the roof drainage system should be internally piped and connected to the stormwater system on the North and South sides of the building. The downspouts observed should be overflow drains only. There are obvious signs of erosion at the downspout locations, which indicates a potential failure of internal system or roof issue. Further investigation is warranted.

Based on the conditions observed and the information provided in the CIMCO report, additional measures to mitigate site drainage contributing to the regional groundwater issues should be a priority to ensure a new installed ice system is protected.

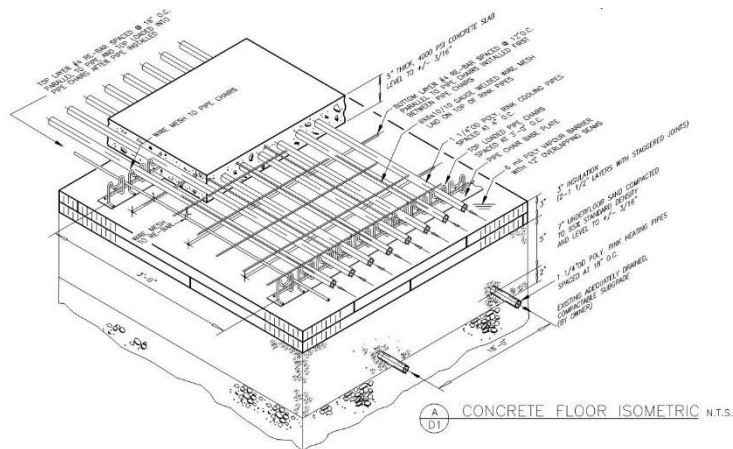
The floor section below the ice rink slabs includes 2 layers of foam insulation, the subfloor heating piping system surrounded by 7 inches of sand fill. The subfloor heating system consists of 1-1/4" OD poly piping at 18 inches on center spacing, fed by 3-inch headers. The drawings do not indicate if the subfloor heating headers are steel or poly, but from site observation it is clear they are steel.

As documented in the CIMCO Report, the Red Rink floor has deteriorated beyond repair from the frost heave associated with the failed heat exchanger. Without a destructive investigation I would suspect that the failure in the heat exchanger is due to the documented high-water table causing corrosion and failure of the steel subfloor heating headers. CIMCO did verify that the subfloor piping is leaking. During development of this report, it was reported by Bill DeBlonk that the Red Rink floor has shown signs of heaving this fall.

The Blue Rink floor, as documented in the CIMCO report, has minor cracking that can be repaired. However, the report indicated that the subfloor heating system is leaking under the Blue Rink as well, which would require complete removal to repair. If the Blue Rink is not repaired, within the next two seasons, it will likely fail like the Red Rink rendering it unusable.

Based on the investigation, both floors and their associated piping systems will need to be replaced. The Red Rink floor should be the priority as it has failed. The Blue Rink floor replacement should be priority number two. I would estimate given the information provided by the piezometer readings that if groundwater conditions stay consistent contributing to the freeze/thaw potential under the floor that the Blue Rink floor could begin to fail within the next two seasons.
