Facility Assessment

Hillcrest Aquatic Center

Brookings, South Dakota

November 18, 2019

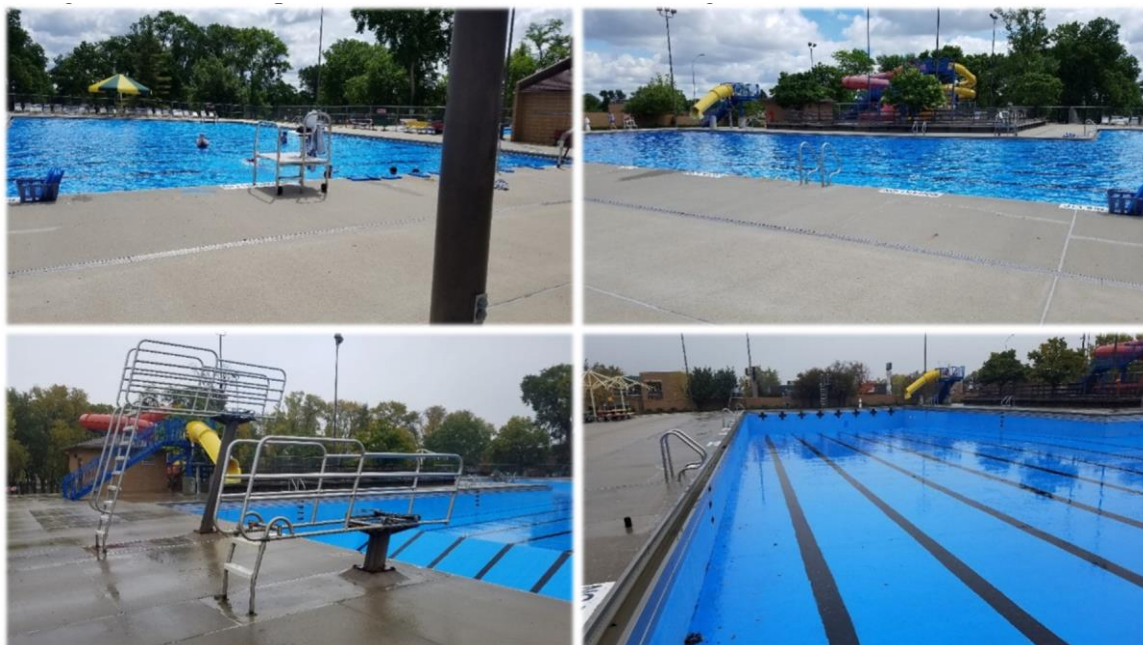
- The main pool is an ell shaped pool consisting of an 8 lane by 50-meter area that is 3ft-9in to 12 ft deep and a shallow ell area that is 2ft to 3ft 6in deep. The shallow area has a set of 'dropped in' stairs and two sets of grab rails and recessed steps. The 50-meter area has five sets of grab rails with recessed steps. The deep end of the 50-meter area has one 1-meter diving board and one 3-meter diving board, and a drop slide. There are three elevated lifeguard chairs.

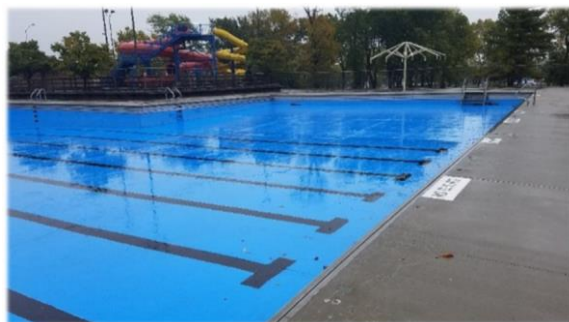
- Federal law requires two means of ADA access to pools with a perimeter of over 300 linear feet. The main pool has more than 300ft of perimeter appears to comply with this requirement.

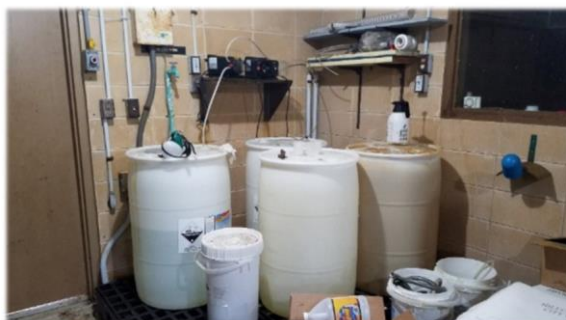
- The chemical treatment system consists of solid chlorine, fed via an Accu-Tab erosion feeder, and acid for pH control, via a peristaltic metering pump. The chemical monitoring and feeding are controlled by a BECS System 3, ORP and pH controller.
 - Payton report that he has no concerns with the treatment system, however, *we would recommend up-grading the controller to a current system, that is more state of the art, with respect to monitoring and feeding with IT connectivity.*

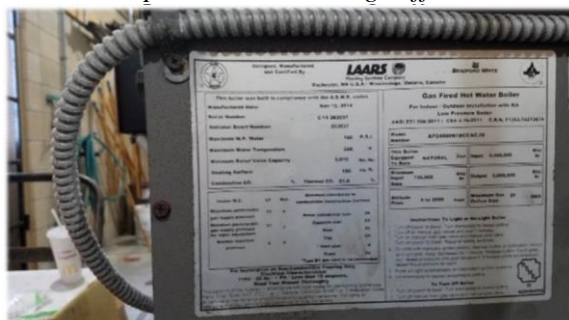
- Chemical Storage: Chlorine agents and pH agents are highly reactive, whether in a liquid, solid, of gas form. *We strongly recommend that these chemicals be separated, as stored in separate areas with physical barriers or stored in separate rooms.*
- The pool heater is a low efficient, open combustion, LAARS direct fired pool heater. Open combustion meaning that combustion air must be provided by the air in the mechanical room. There is often not enough air in the room for proper combustion, and any vapors from off gassing are sucked into the combustion chamber of the heater. This situation causes condensation and corrosion in the heater.
 - *We recommend replacing the heater with a high efficient, sealed combustion, pool heater or a high efficient condensing boiler with heat exchanger.*

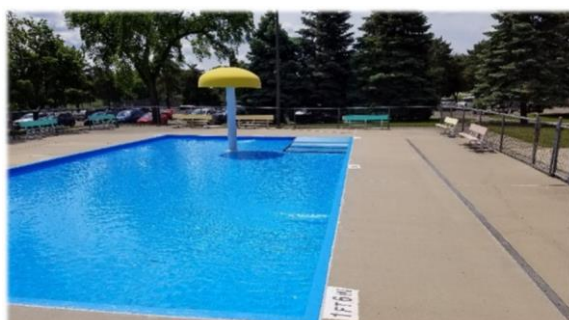
- The wading pool is fenced off from the main pool and accessible directly, without controlled access via the admission area. The wading pool is isolated from the rest of the aquatic areas and cannot be monitored from the main aquatic area, resulting in a safety concern. The other concern with this pool is the possibility of cross contamination with the main pool. Fecal accidents are more likely in this type of pool, and with the limited control of this pool, fecal contamination and/or a crypto outbreak could likely force closer of both pools.

- *We recommend removal of the wading pool.* We further understand that the wading pool is a free amenity for users but lacks controlled access and monitoring.

- If the city wants to provide a free aquatic amenity, *we recommend removal of the wading pool and replacement with a splash pad, similar to the splash pad next to the leisure pool.* This splash pad would have its own operating system and with no standing water, would not require any lifeguarding.

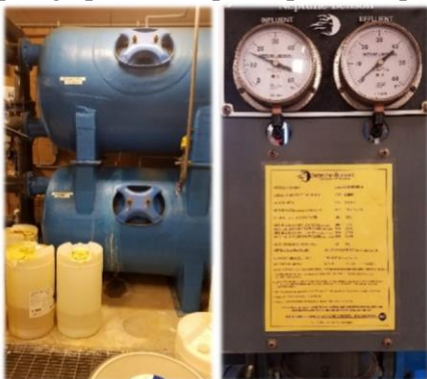
- Recirculation is via the main drains and surface skimmers.
 - The main drains should be checked for expiration dates to comply with VGB.*
- In review of the operating system, Payton reports that there are no concerns with the system. The filters are piggy backed and are high rate sand media filters. The filters have single lever linkage and Payton reports that the valves are properly linked. The filters are properly sized for appropriate turnover of the plunge pool. The pool operator reports that he backwashes the filters once a week.

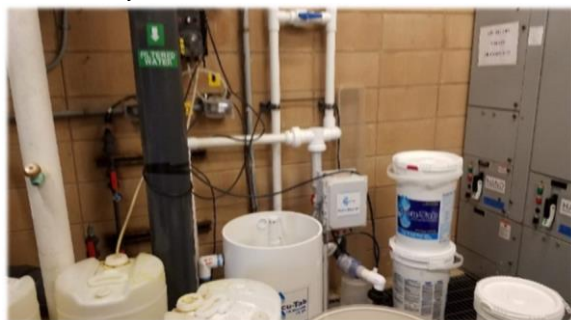
- The chemical treatment system is the same as the main pool, including the chemical controller, a BECS System 3.
 - We would recommend an upgrade to a current system with modern capabilities such as IT connectivity.*

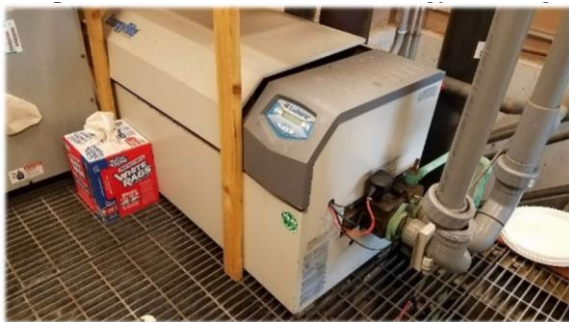
- Chemical Storage: Chlorine agents and pH agents are highly reactive, whether in a liquid, solid, or gas form. *We strongly recommend that these chemicals be separated, as stored in separate areas with physical barriers or stored in separate rooms.*
- The pool heater is a Lochinvar EnergyRite, high efficient with a sealed combustion chamber.

- In our opinion, the only concern with the plunge pool and waterslide area is the location. It is isolated from the rest of the aquatic facility and off the deep end of the main pool. The activities associated with this amenity are more leisure/recreational oriented and a better location for this amenity would be next to the leisure pool. In review of an aerial map, it appears that there would be room for this amenity Northwest of the leisure pool and East of the mechanical room for the leisure pool. The existing location of the waterslides has 'curb appeal' from 6th Street. Relocating this amenity to the Northwest area of the facility would retain the 'curb appeal'. This would be a better location for not only patrons, but also for lifeguard staff and maintenance staff.

- *We recommend relocating the plunge pool and water slides.* Relocating this amenity would also allow for a better orientation for a possible expansion and addition of an indoor aquatic facility.

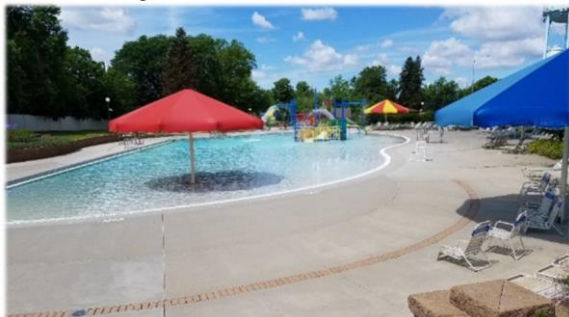
- The free form, zero depth entry, leisure pool, with water play elements is a great amenity to the aquatic facility. The pool was constructed in 2005 and appears to be in good condition with a few exceptions. The pool wall, on the South side, does need reconstruction work. It appears that the pool was constructed with a cold joint about a foot down from the pool rim. This joint is spalling and deteriorating.

- We recommend this joint be reconstructed to preserve the longevity and performance of the pool structure. The quartz aggregate pool finish is in OK to poor condition. In other words, some areas appear OK and other areas show wear and spalling. There also a few patched areas. The expansion joint in the pool floor and wall needs routine maintenance to ensure longevity and to remain watertight. A new quartz aggregate finish is not an immediate need, however, if the reconstruction of the pool wall is completed soon, we would recommend a new pool finish at the same time. If the City opts to operate the pool 'as is' for the 2020 swim season, this work could be scheduled to be completed in the fall of 2020, so it does not interrupt a swim season.*

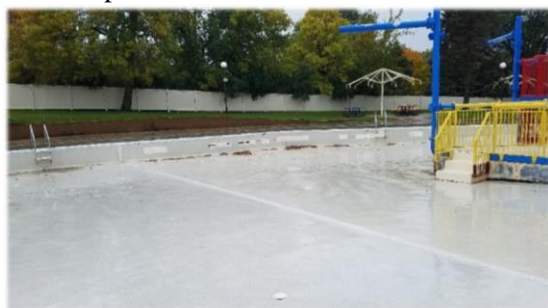
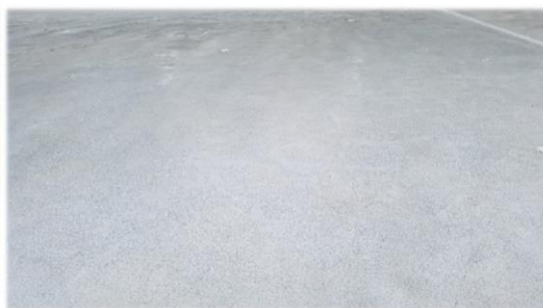
The water play elements appear to be in fair condition. There is rust showing on some areas of the play elements. Also, some of the steps show delamination of the coating.

- We recommend sandblasting and recoating rusting areas and delaminated steps.*

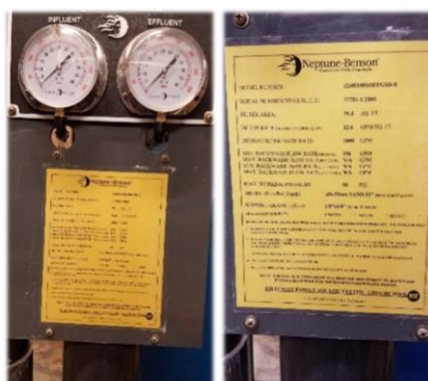
- The filtration system consists of dual, high rate sand media filters, with single lever linkage. Payton reports that these filters are in good working order. The pool operator reports that he backwashes the filters once a week. These filters should provide adequate service for filtering pool water for several years.
 - *When these filters need replacement, in the future, we would recommend upgrading the filtration system to a single regenerative media filter. Again, the regenerative media filtration system will provide better quality of pool water at less operational costs.*

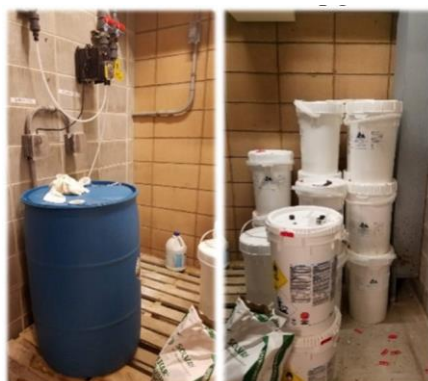
- The chemical treatment system is the same as the main pool, including the chemical controller, a BECS System 3.
 - *We would recommend an upgrade to a more modern system.*

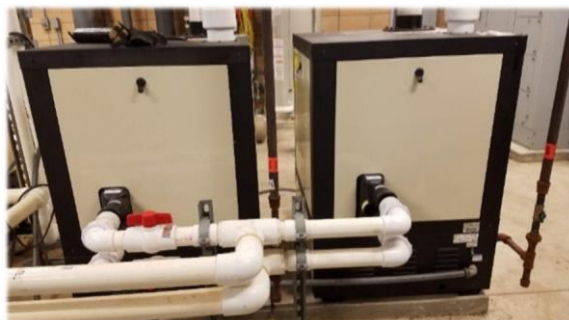
- The pool is heated with dual, high efficient, direct fired pool heaters with sealed combustion chambers. Payton reports that the combustion air intake gets plugged with moths as the intake air piping is located close to night lighting.
 - *We recommend relocating the air intake and adding a larger intake cover to increase the cross-sectional area. Staff reports that the city is working with the heater vendor to resolve this issue.*

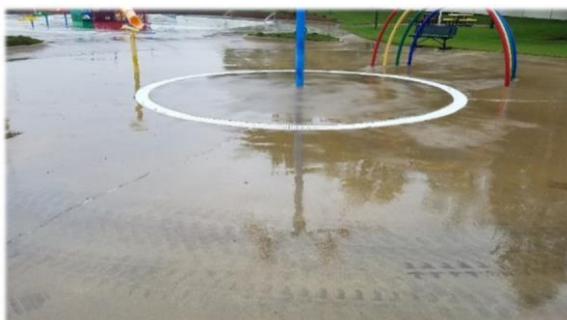
- Since there is no standing water, the recirculated water is contained in a buried storage (surge) tank located on the Southeast corner of the mechanical room, adjacent to the surge tank for the leisure pool. The water play elements also receive water from the surge tank and distribute water to the individual play elements, via a dedicated pump and motor.
- The filtration system consists of single, high rate sand media filter, with a port type dial valve. Payton reports that the filter is in good working order and that he backwashes the filter once a week. The filter should provide adequate service for filtering pad water for several years.

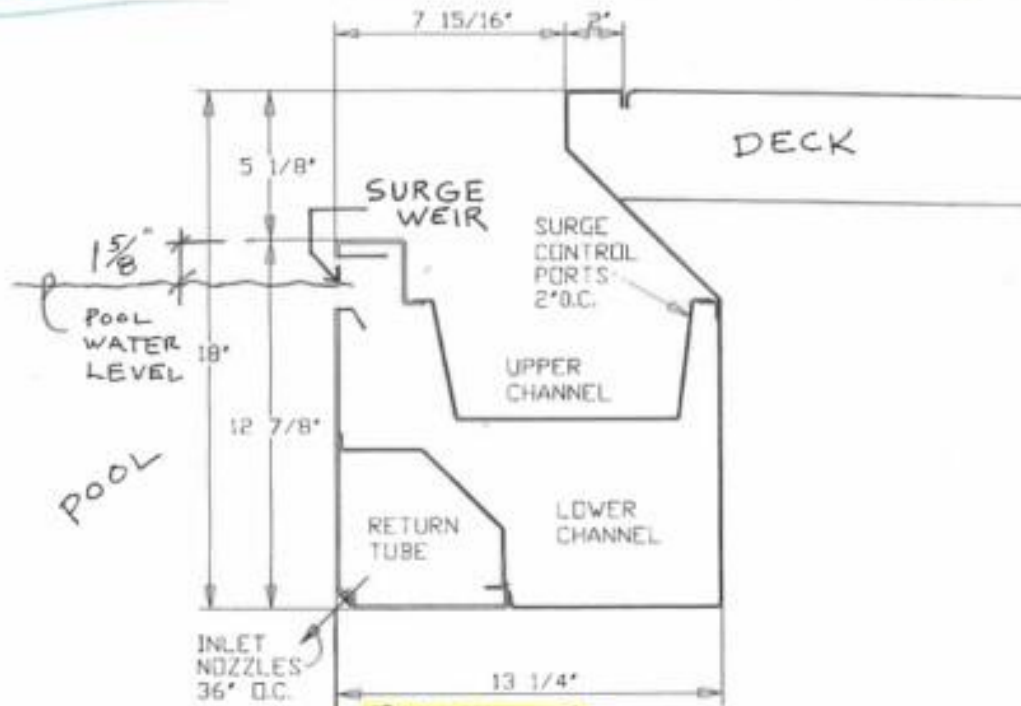
**EXISTING
SCRS SYSTEM**

- The pool perimeter has a stainless-steel recirculation system that delivers filtered water back to the pool and removes surface water via surface weirs. This recirculation system was installed on the existing pool structure in 1984. The recirculation system incorporates a two-tiered gutter system with surface water entering the lower gutter via the surface weirs and bather displaced water entering the upper gutter via rim overflow. The upper gutter is an open trough, with no grating over it. The two concerns with this gutter type are that, one, the weirs do not allow total rim flow and act only as occasional area surface skimming, like a skimmer pool, and two, the open gutter is a safety concern for bathers.
