Additional Narrative

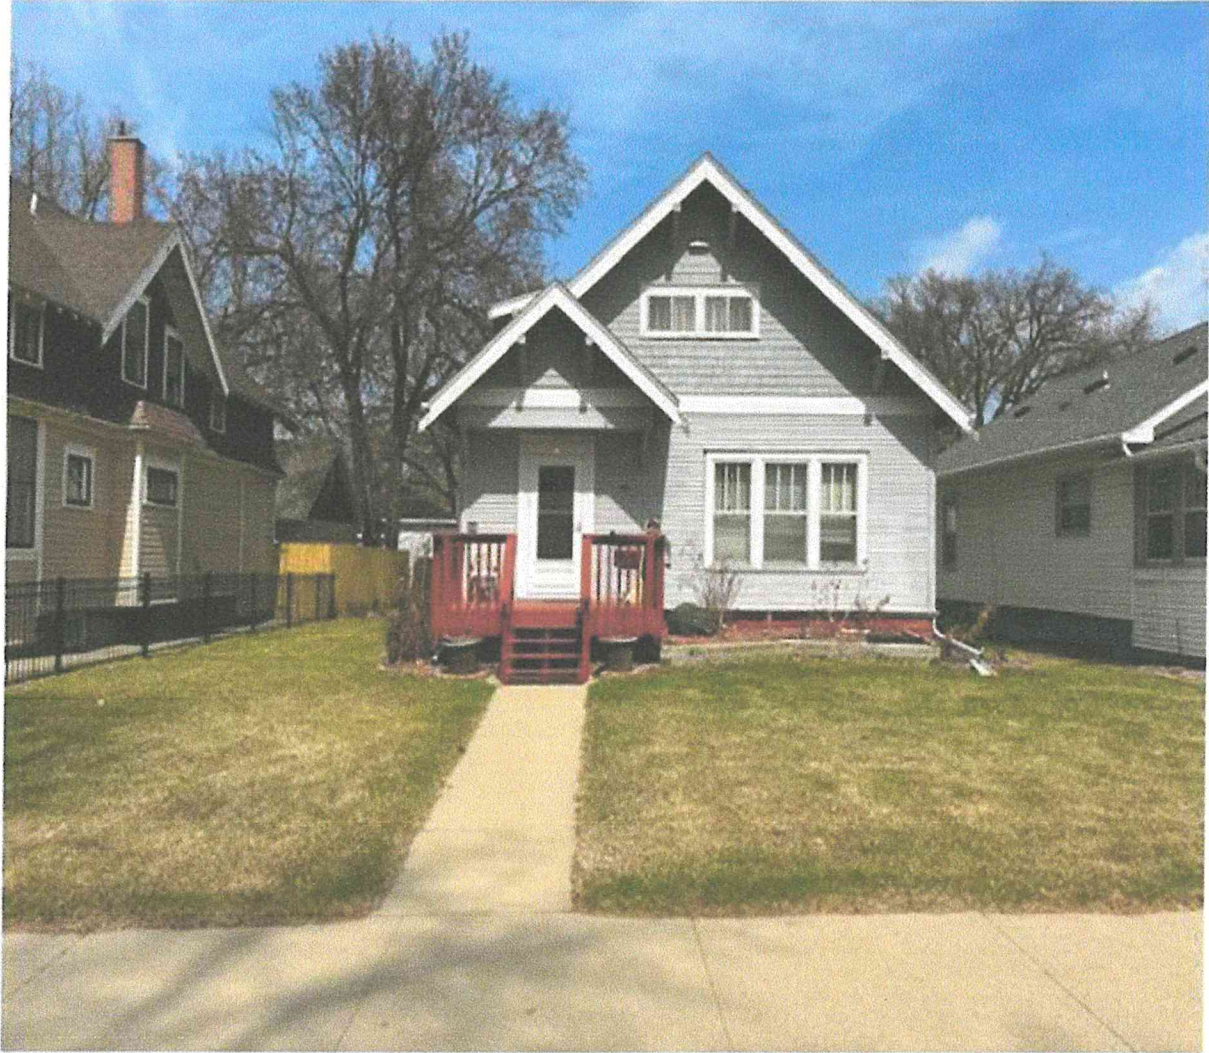
Fig.1 Looking North at front of 805 4th St

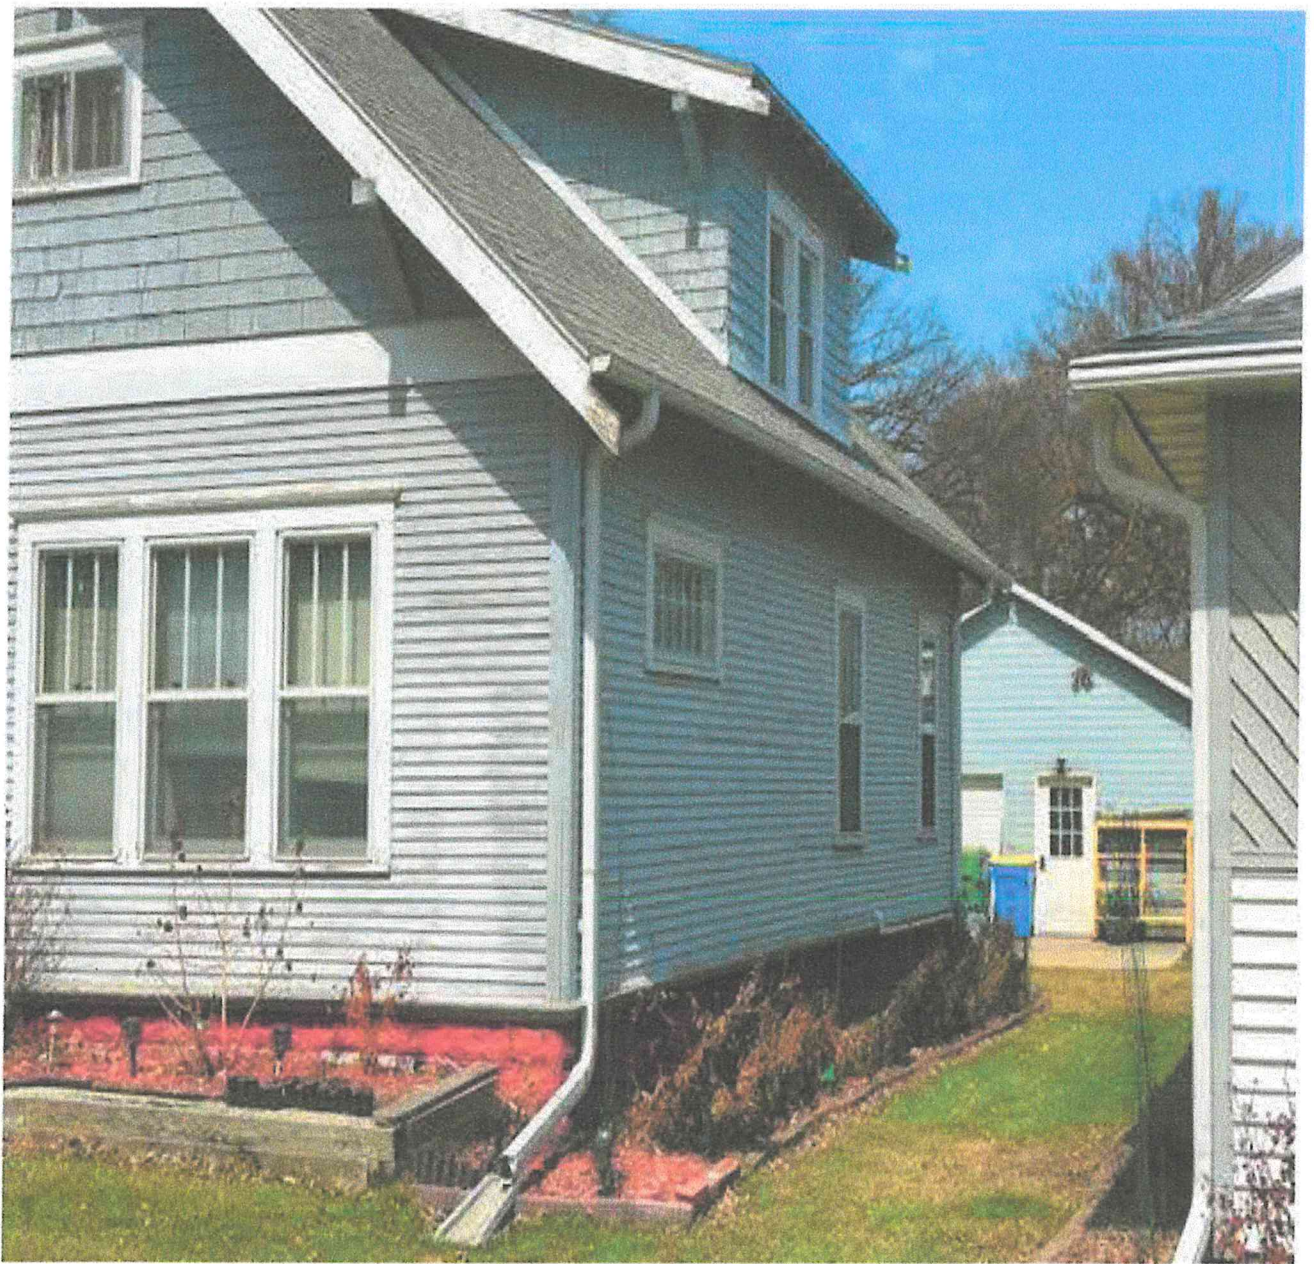
Fig. 2. Looking East side of main house at 805 4th St.

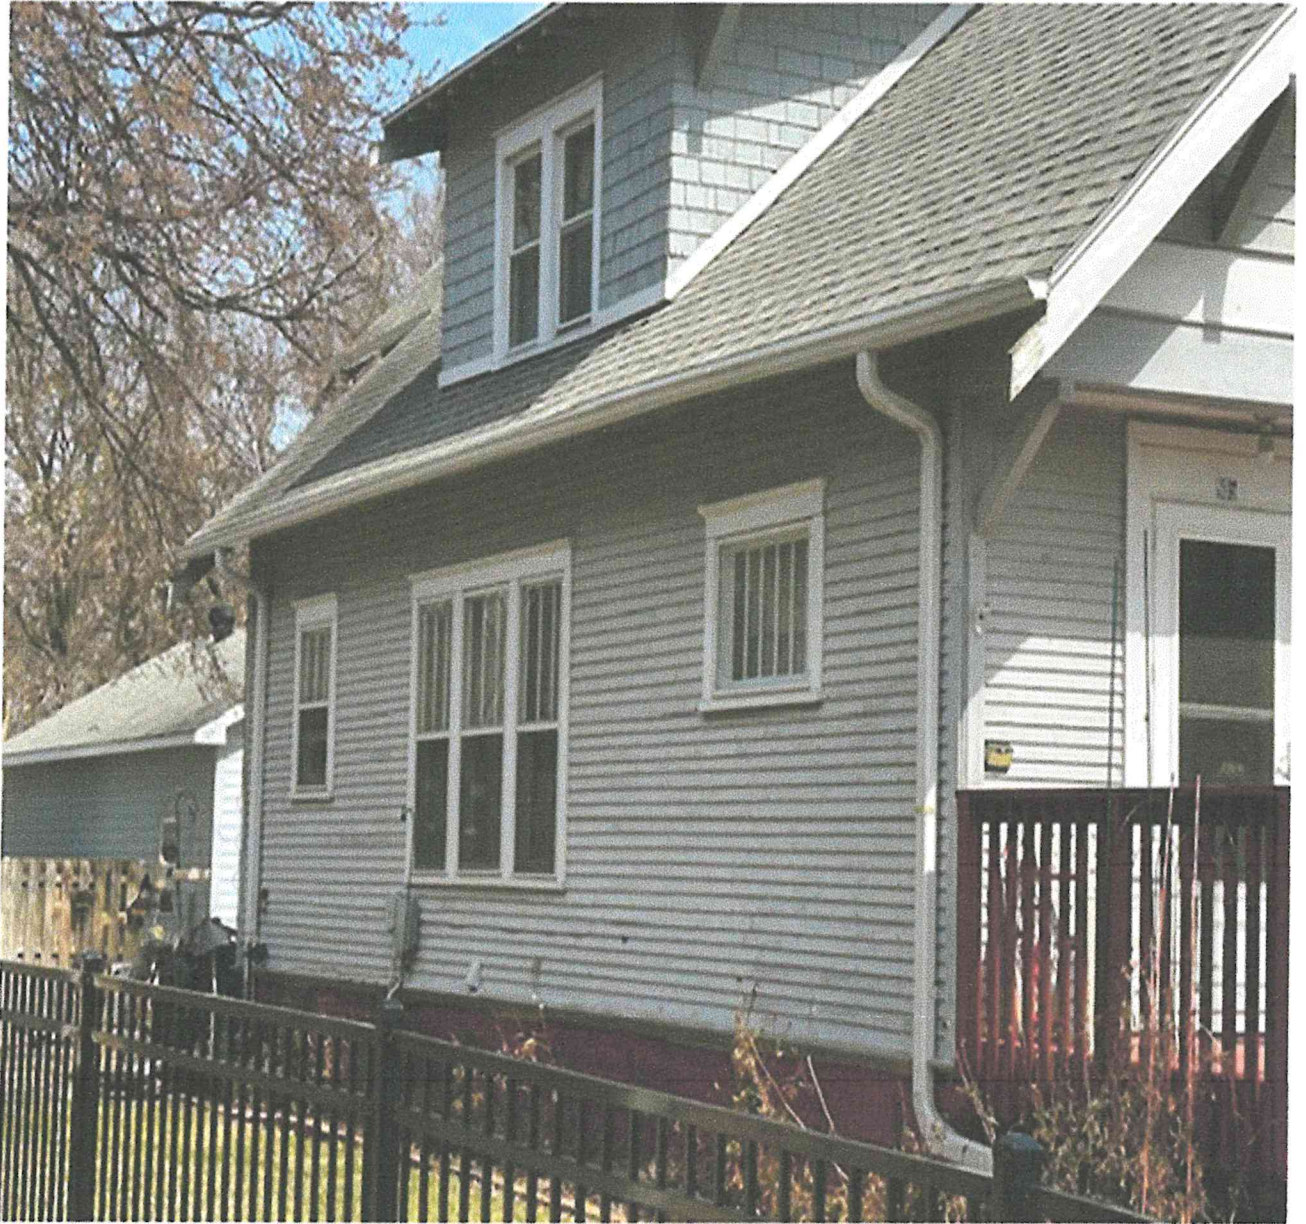
Fig.3. Looking at West side of main house at 805 4th St.

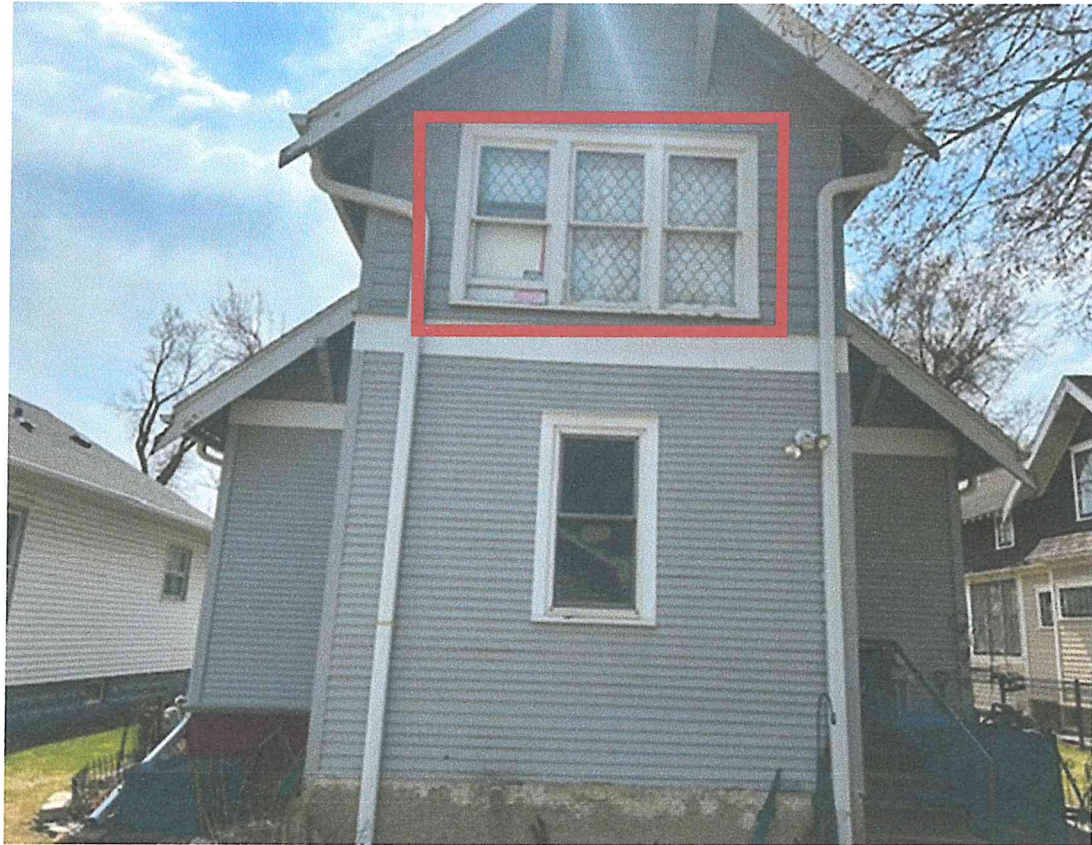
Fig.4. Looking at North exterior wall of porch located on main house at 805 4th Street
Note: 3 double -hung windows on upper level to be replaced.

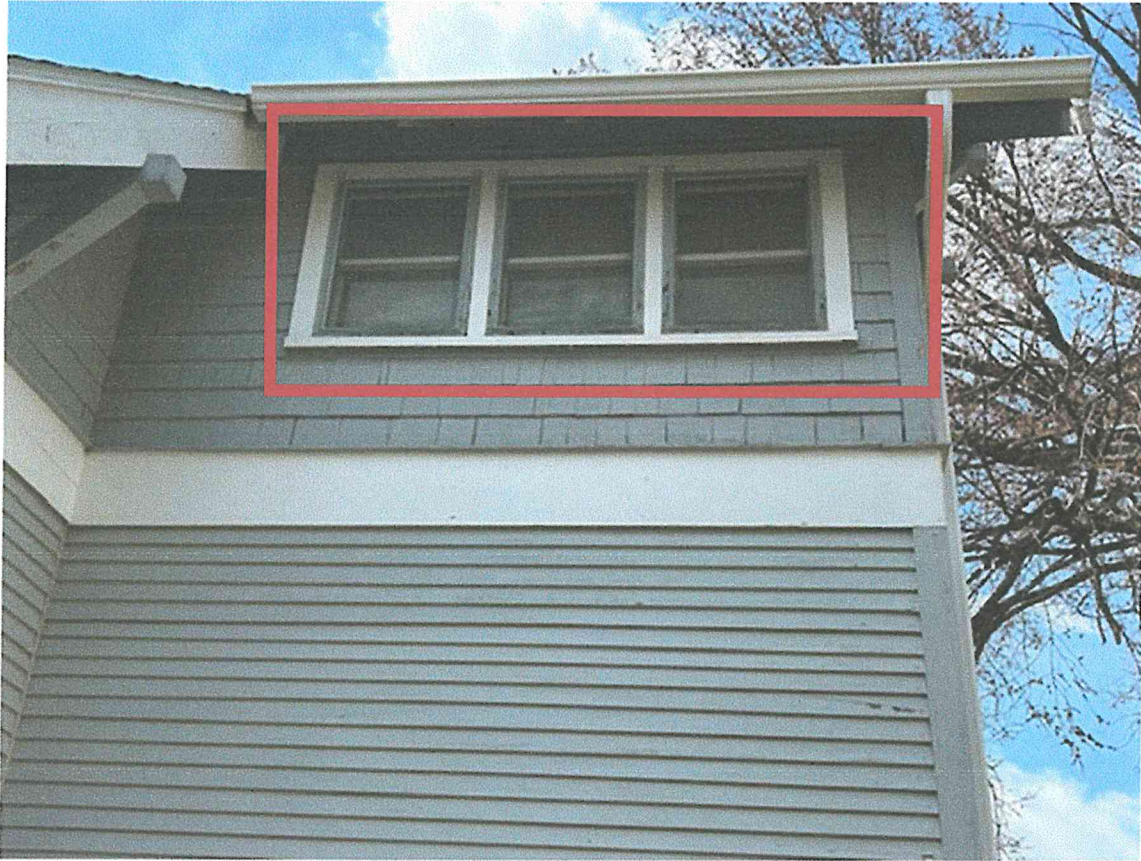
Fig.5. Looking at East exterior wall of porch located on North end of main house at 805 4th Street

Note: 3 double -hung windows on upper level to be replaced.

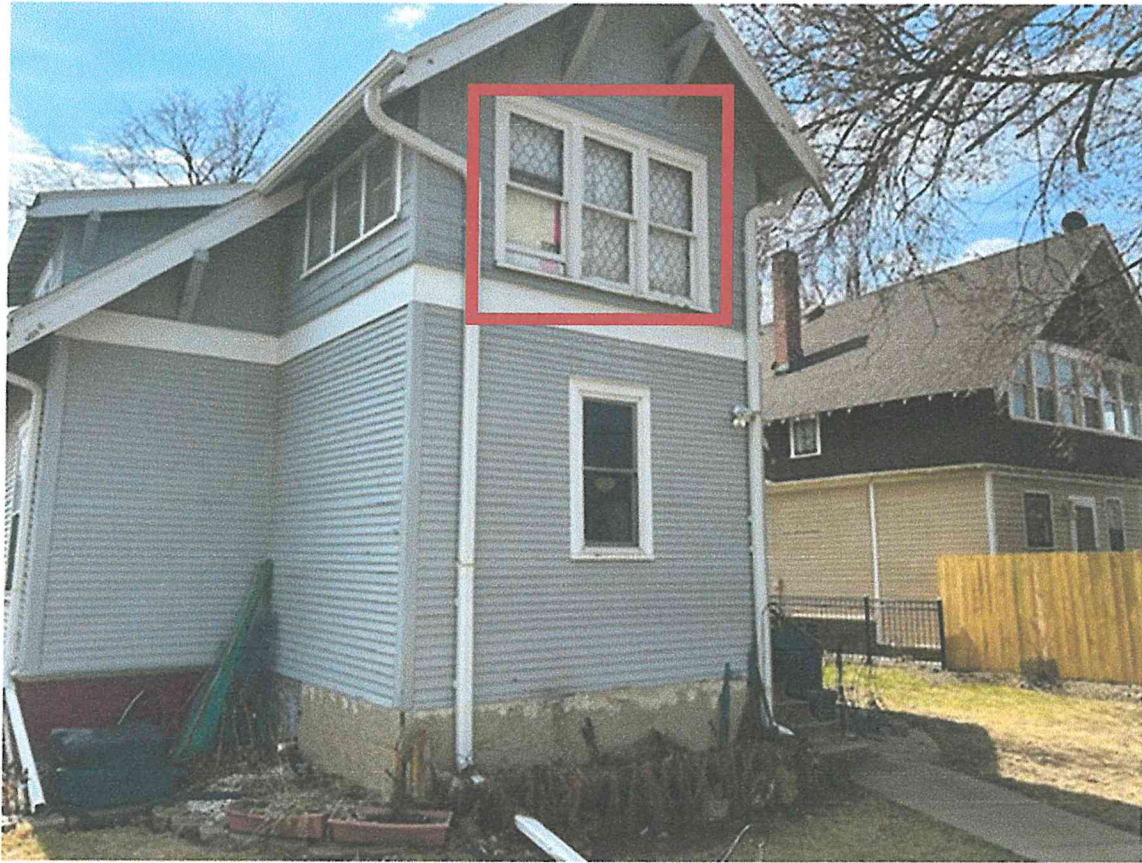
Fig.6. Looking at North exterior wall of porch located on main house at 805 4th Street
Note: 3 double -hung windows on upper level to be replaced.

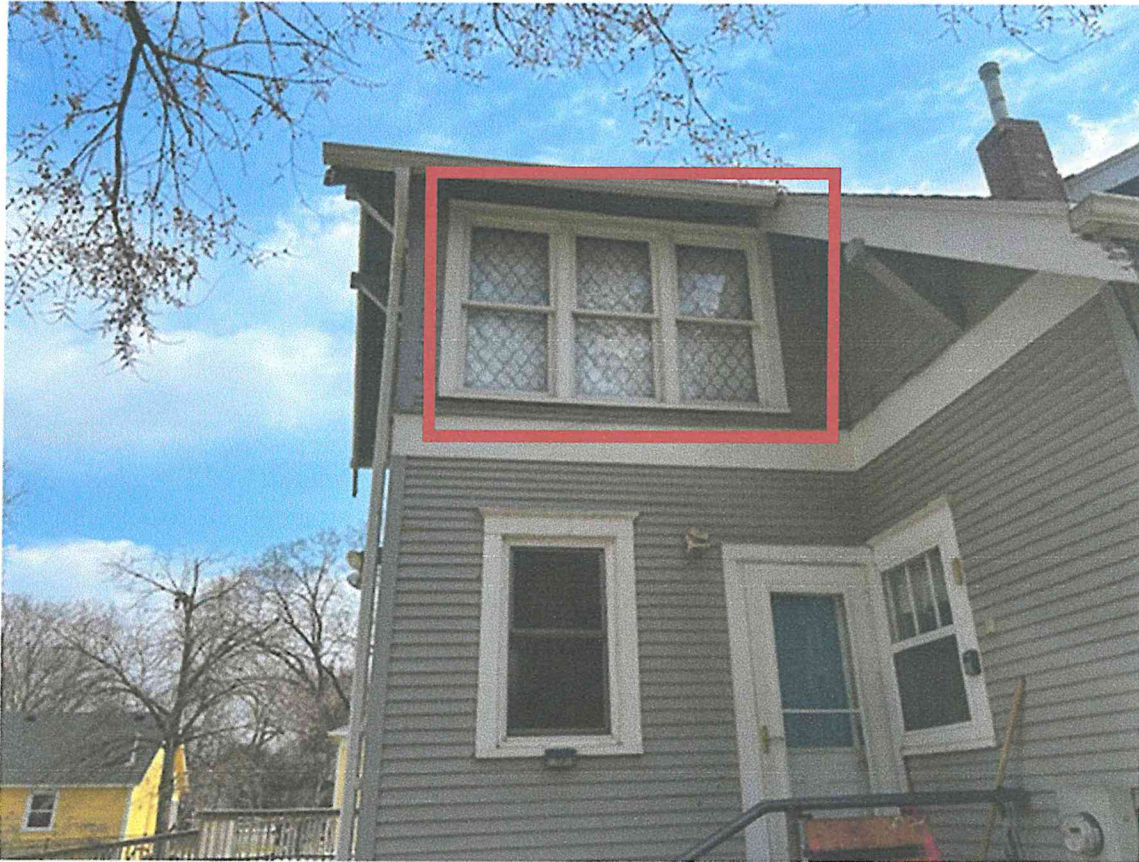
Fig.7. Looking at West exterior wall of porch located on main house at 805 4th Street

Note: 3 double -hung windows on upper level to be replaced.

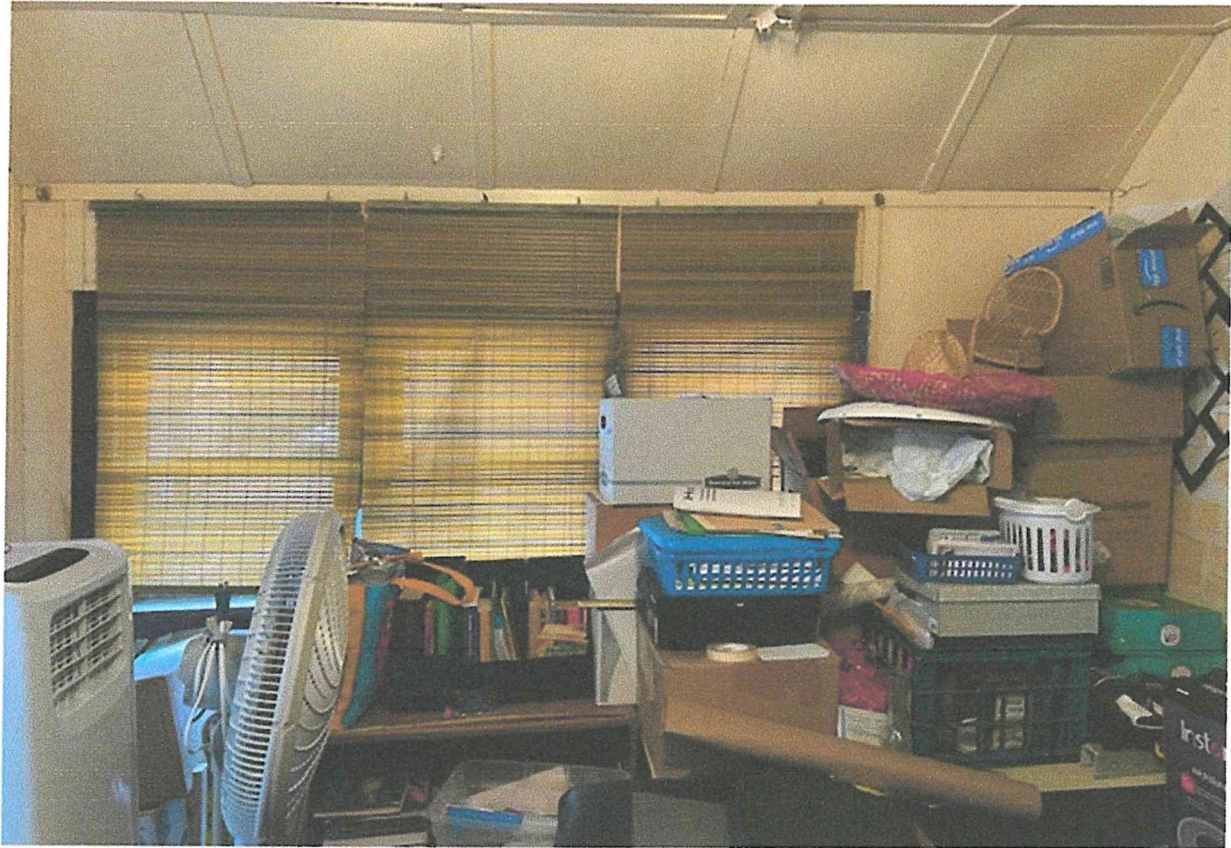
Fig.8. Looking at East interior wall of porch located on main house at 805 4th Street
Note: 3 double -hung windows with wood paneling and ceiling to be replaced insulated

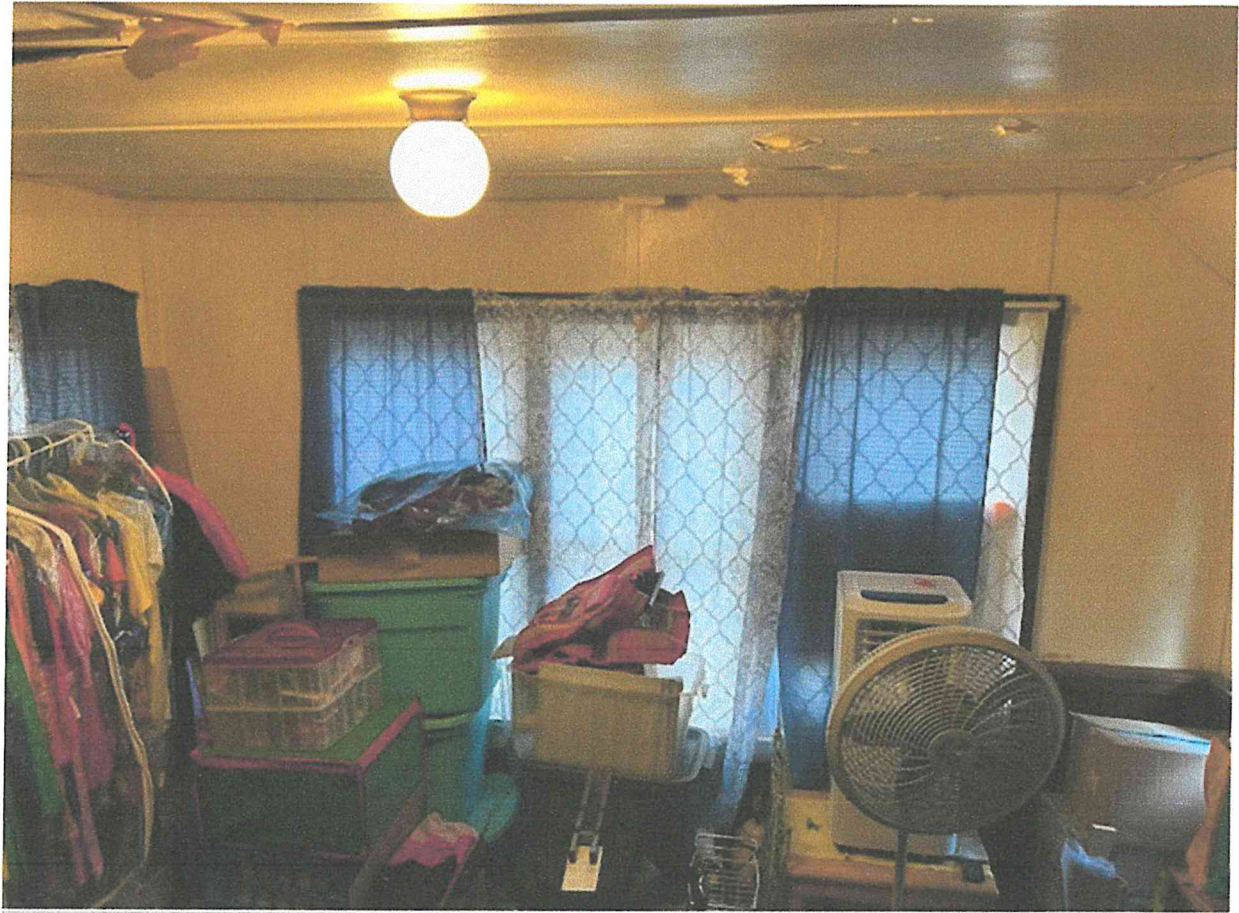
Fig.9. Looking at North interior wall of porch located on main house at 805 4th Street
Note: 3 double -hung windows with wood paneling and ceiling to be replaced insulated

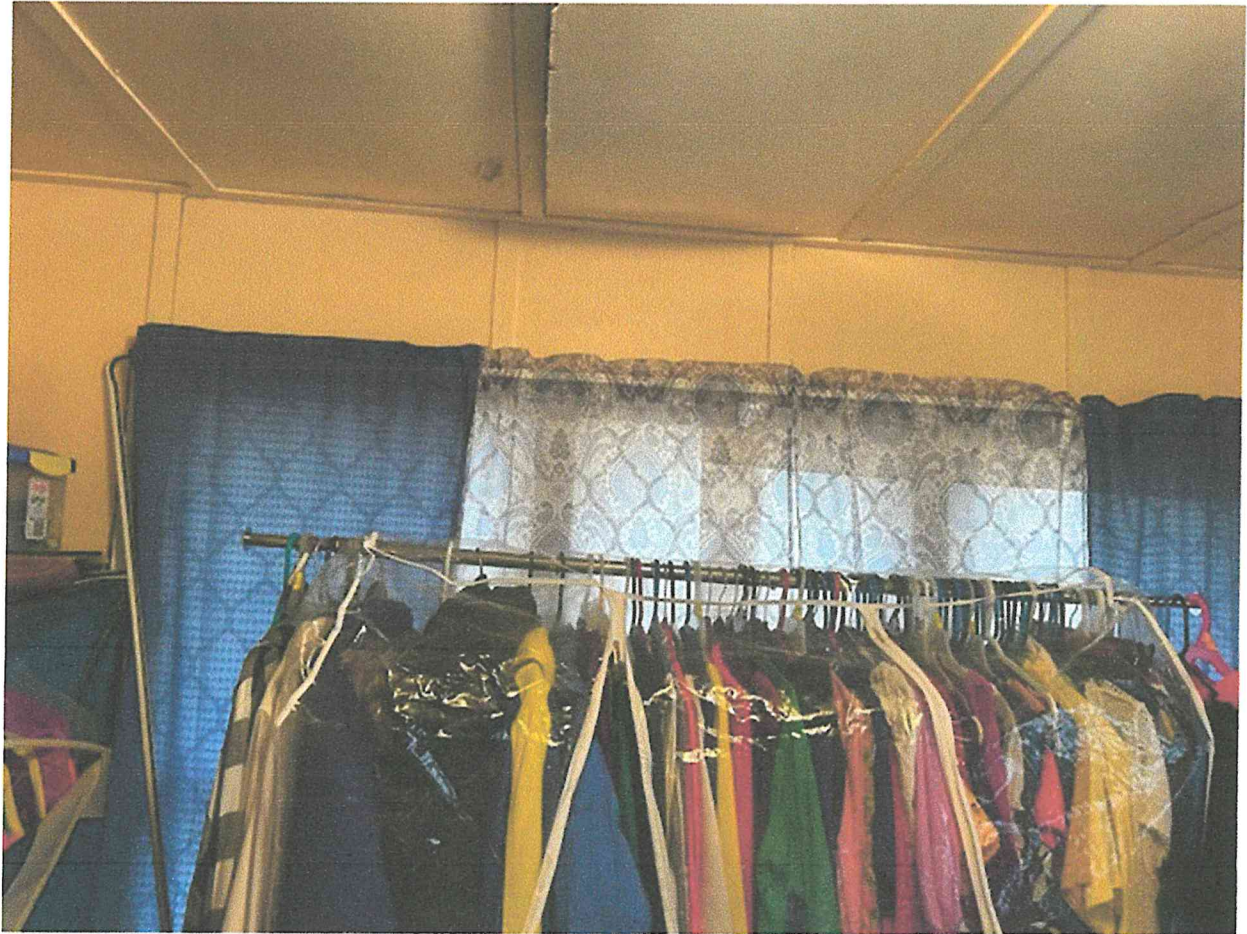
Fig.10. Looking at West interior wall of porch located on main house at 805 4th Street
Note: 3 double -hung windows with wood paneling and ceiling to be replaced insulated

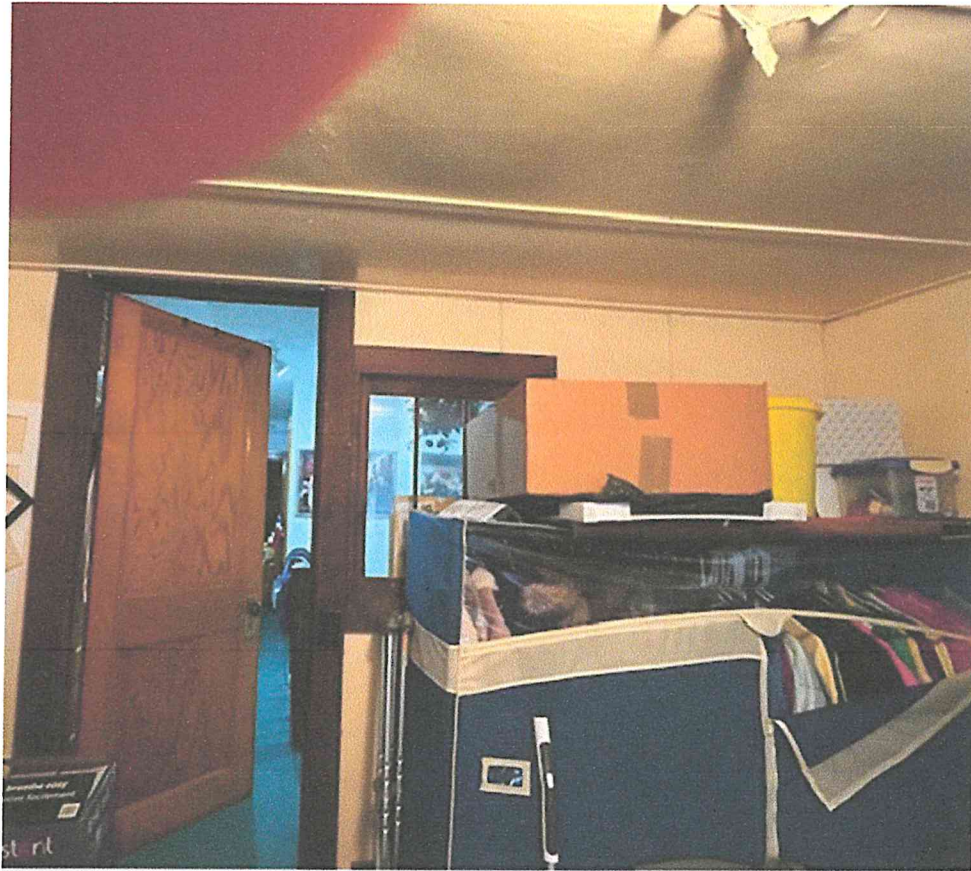
Fig.11. Looking at South interior wall of porch located on main house at 805 4th Street
Note: wood paneling and ceiling to be replace/ insulated

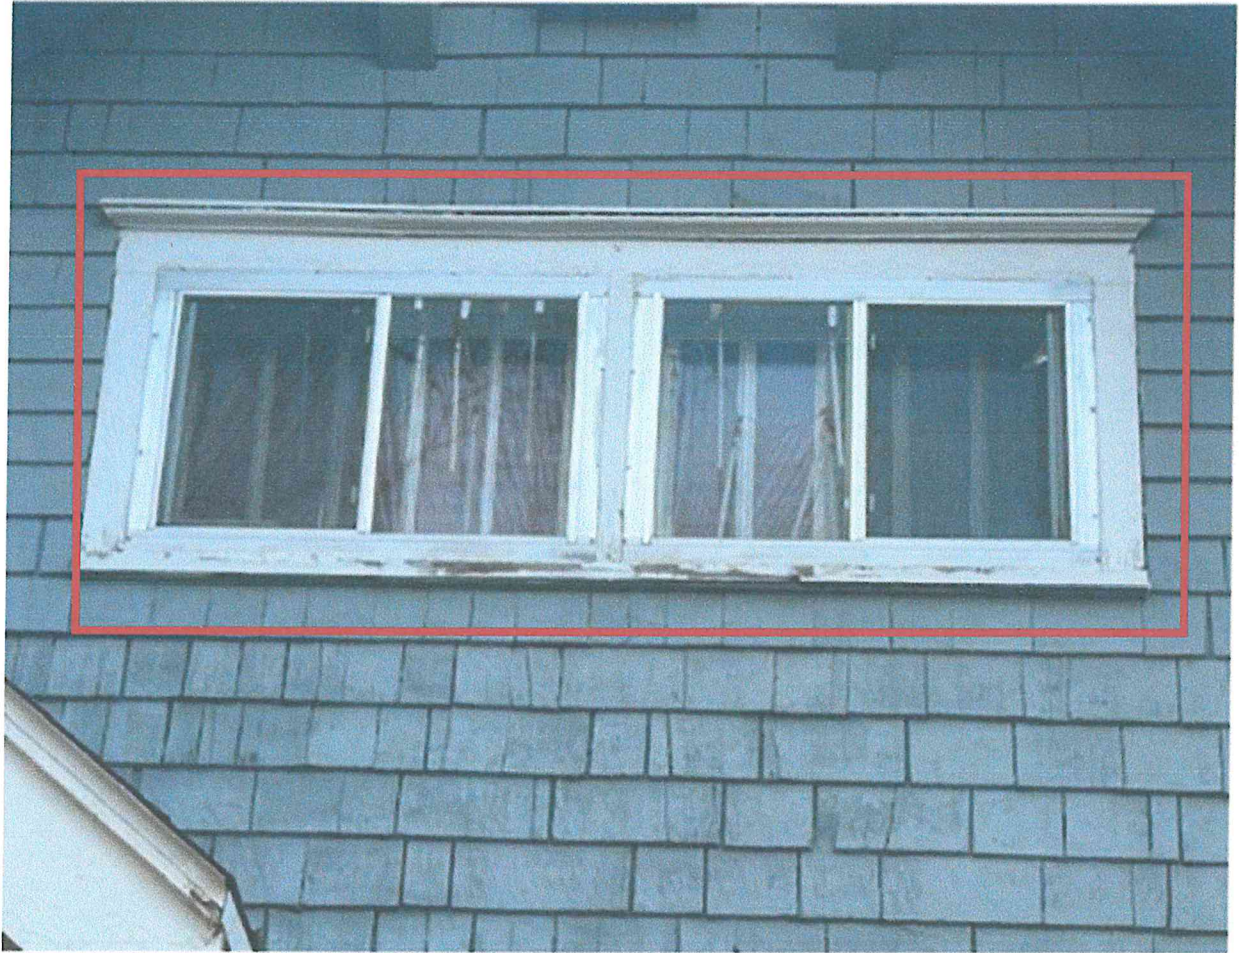
Fig.12. Looking at South exterior wall of main house at 805 4th Street

Note: Two windows swing inwards with 2 sliding glass screen exterior storm windows.

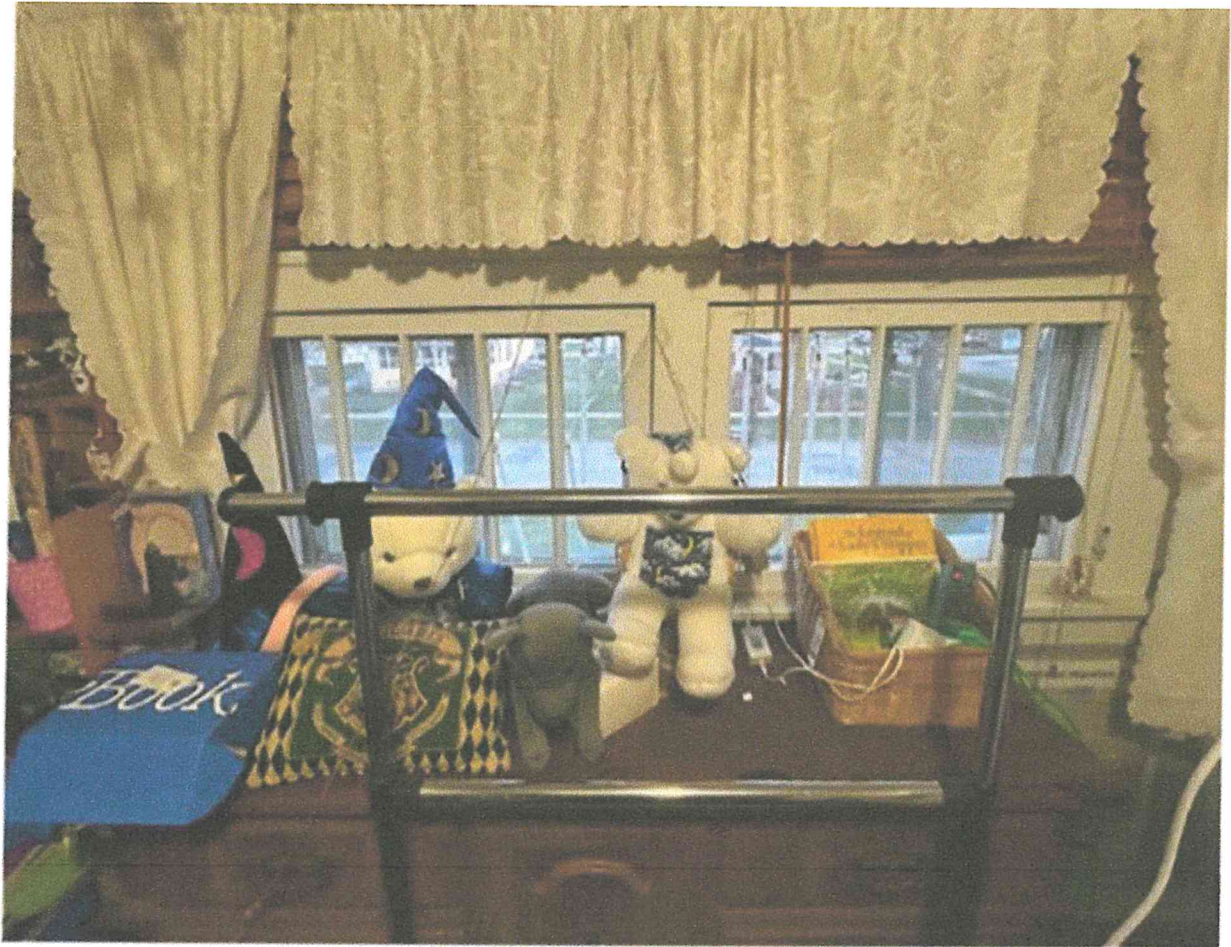
Fig.13. Looking at South exterior wall of main house at 805 4th Street

Note: Two windows swing inwards with 2 sliding glass screen exterior wall.

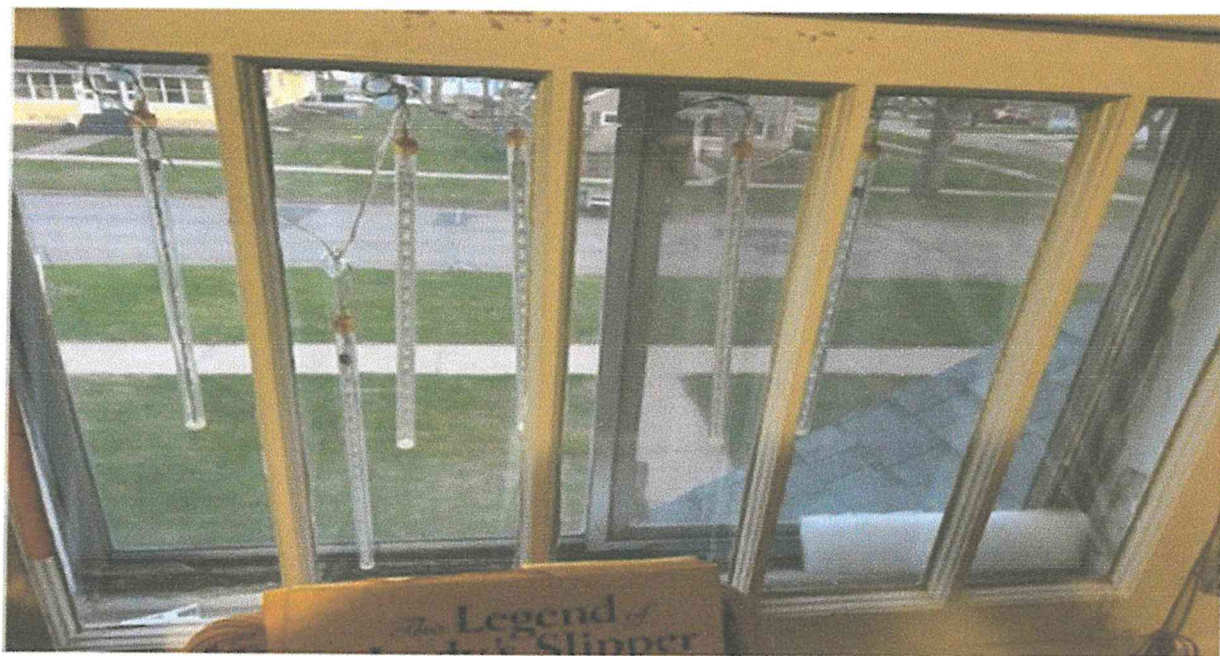
Fig.14. Close up of one window shown in Fig.11 and Fig.12

**Note: This shows interior wood window and exterior storm windows.
Hanging in windows are Xmas lights which have not been removed.**
