3M Brookings, Soil and Ground Water Assessment December 2024 Update

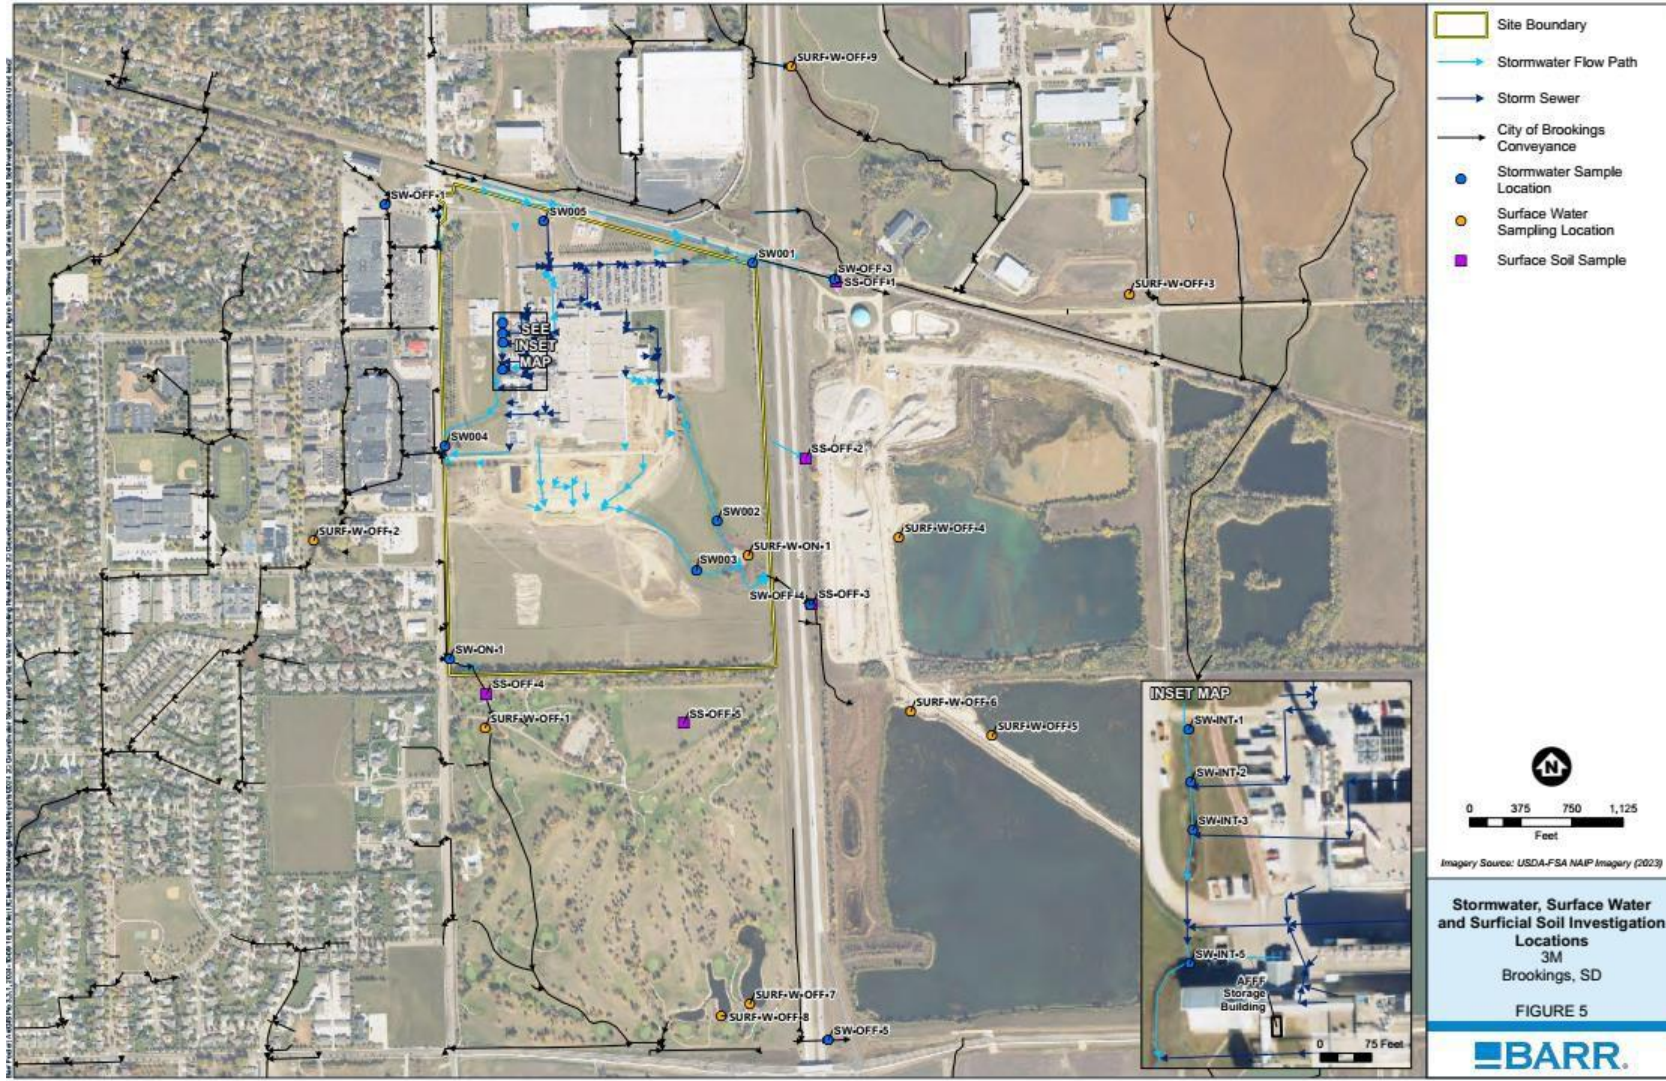
Site Assessment

With approval of DANR conducted:

- Quarterly monitoring at on- and off-site groundwater wells
- Additional soil, stormwater, and surface water sampling
- Report submitted to DANR, City, and BMU on November 14, 2024

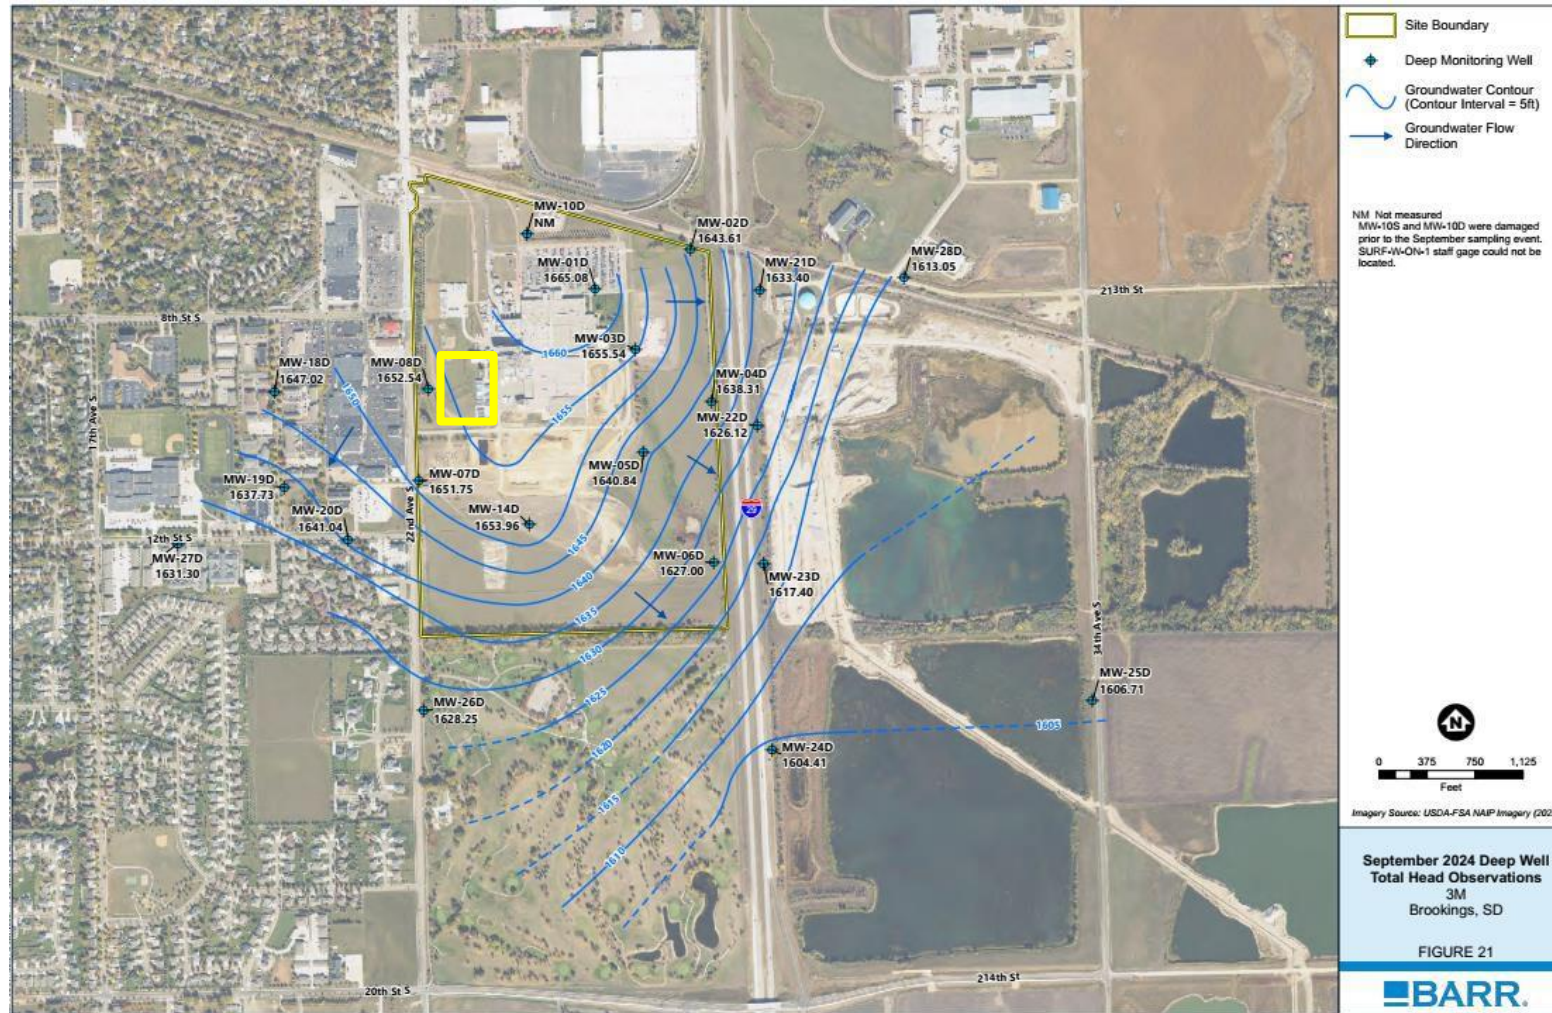
Assessment Results

Key Points:

- Groundwater flow direction is radial, reflecting topography
- Highest PFAS concentrations were detected on the west side of the plant on Solventum property
- Environmental consulting firm developed recommended next steps

- Install an interim stormwater treatment system near 22nd Ave. west of plant
- Develop a focused soil sampling and removal plan
- Continued quarterly groundwater monitoring of existing onsite & offsite wells
- Submittal of an annual groundwater monitoring report to summarize on-going assessments and monitoring
- Continue to work with SD DANR, BMU and city of Brookings

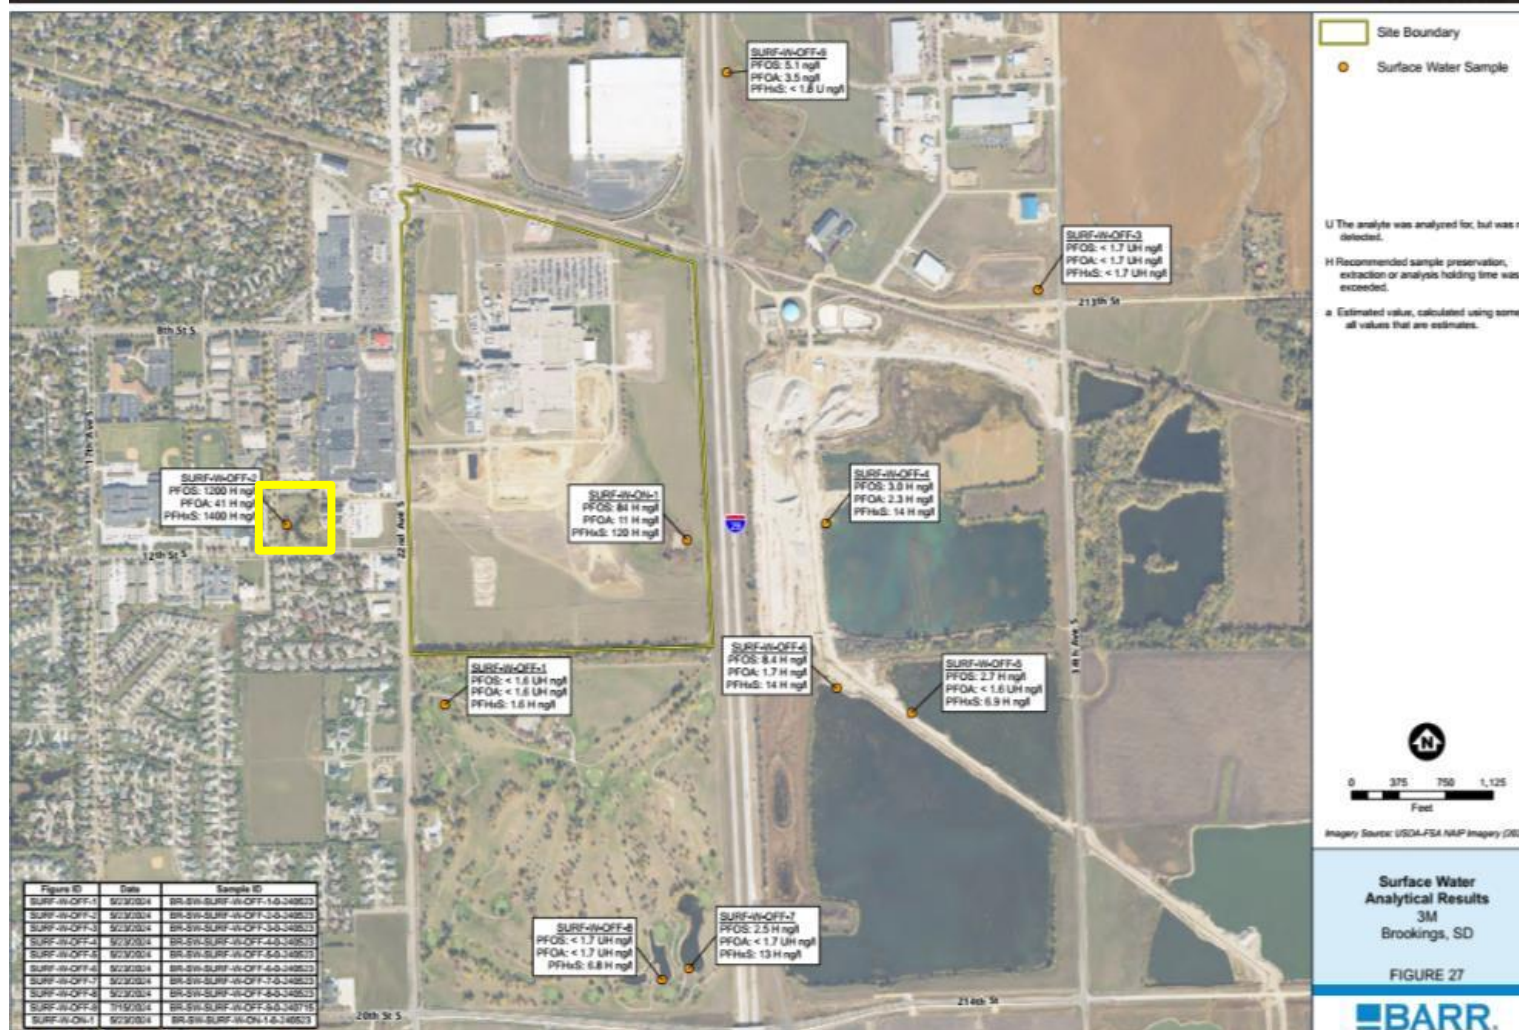
Offsite Surface Water Assessment

Key Points:

- Offsite surface water sampled in gravel pit, golf course, stormwater ponds
- Partnering with SD DANR on next steps
