SOUTH DAKOTA STATE HISTORICAL SOCIETY
STATE HISTORIC PRESERVATION OFFICE (SHPO)
SOUTH DAKOTA CODIFIED LAW 1-19A-11.1 CASE REPORT

Continuence Project # 250829002S Facade Renovation
☒ This is a new submittal. ☐ This is information relating to SHPO project number:

The building located at 315 Main Avenue in Brookings, South Dakota, required significant façade stabilization and renovation due to deterioration of the original brick materials. The lower storefront brick was crumbling and missing in areas, and modern steel columns had been installed in the past to support the structure. These changes made it infeasible to replicate the original masonry construction method.

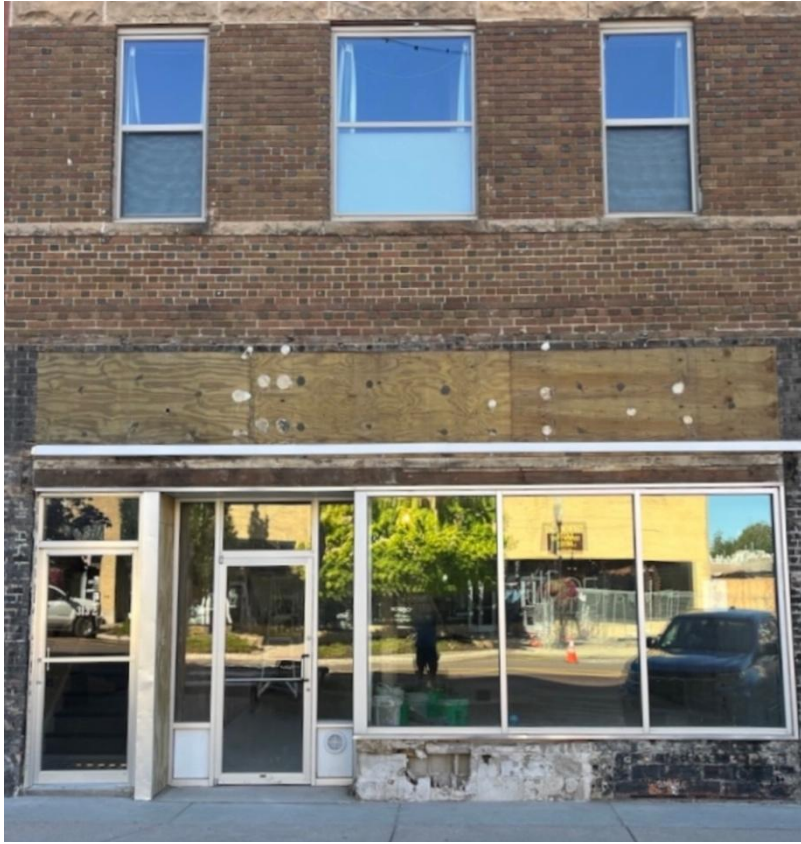
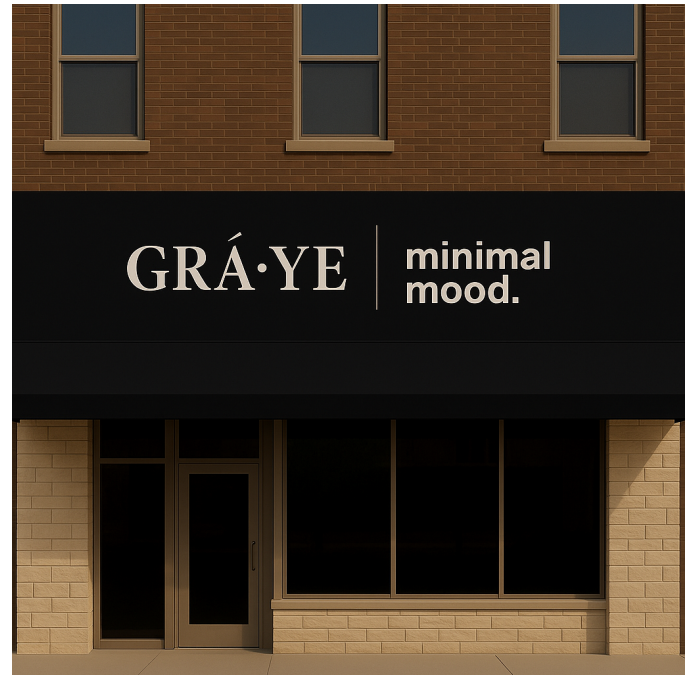
Awning: 52” tall with a 6” solid valance that is 280” wide and has a 32” projection – traditional style with an open bottom.

The property is a two-story brick commercial building located on Main Avenue within the Brookings Historic District. The upper story retains its original dark brickwork and three evenly spaced windows, while the lower level has been repaired with buff-tone masonry to address structural deterioration and fill areas where holes had developed in the façade. The storefront features a traditional early 20th-century commercial layout, characterized by a recessed entry door flanked by large display windows.

- Replacement of deteriorated brick with Arizona Dry Stack stone along the storefront base. The selected stone closely resembles a buff tone that was widely used in historic architecture across the Midwest during the late 19th and early 20th centuries. Importantly, buff-colored masonry has a proven record of blending naturally into historic districts: as time passes, the stone's surface weathers and patinas in a way that becomes visually continuous with older materials, making it feel like a natural extension of the original building fabric.

- Installation of a black fabric awning to provide weather protection, visual definition, and to enhance pedestrian-scale interest. The awning dimensions were selected to fit the existing storefront without overpowering historic elements.
