Facility Assessment

Hillcrest Aquatic Center

Brookings, South Dakota

November 18, 2019

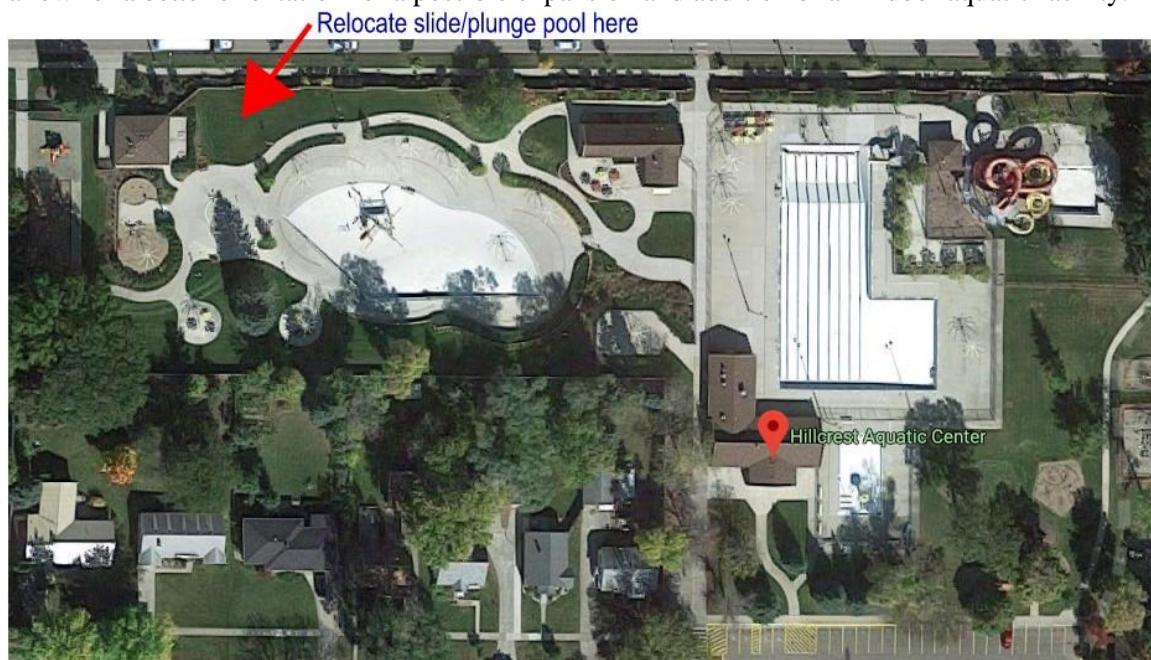
- In our opinion, the only concern with the plunge pool and waterslide area is the location. It is isolated from the rest of the aquatic facility and off the deep end of the main pool. The activities associated with this amenity are more leisure/recreational oriented and a better location for this amenity would be next to the leisure pool. In review of an aerial map, it appears that there would be room for this amenity Northwest of the leisure pool and East of the mechanical room for the leisure pool. The existing location of the waterslides has 'curb appeal' from 6th Street. Relocating this amenity to the Northwest area of the facility would retain the 'curb appeal'. This would be a better location for not only patrons, but also for lifeguard staff and maintenance staff.

- *We recommend relocating the plunge pool and water slides.* Relocating this amenity would also allow for a better orientation for a possible expansion and addition of an indoor aquatic facility.

- If the plunge pool and waterslides are relocated, *we would recommend a deeper water area, connected to the plunge pool, that could facilitate the drop slide, jump platforms and aquatic climbing wall.* The usage of the drop slide would be better suited for this area rather than having it on the 50-meter pool.
