CITY OF BROOKINGS | 2025 BRIDGE INSPECTIONS

NOVEMBER 18, 2025

Bridge Inspection Overview

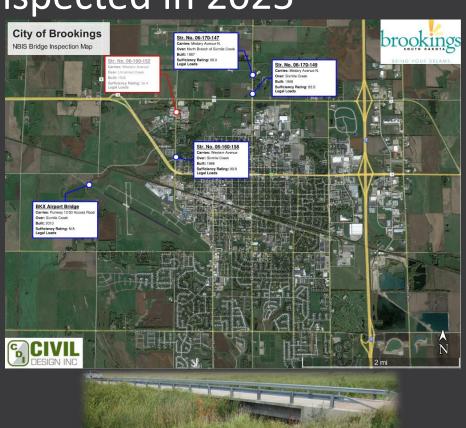
Str. No. 06-170-149
67.0' 3-Span Continuous Concrete Bridge
Built in 1968

STR. NO. 06-170-149 INSPECTION TAKEAWAYS:

- Condition Rating = 5 (Fair Condition)
- Existing Concrete Overlay is to the end of its useful life and will require removal and replacement in the future.
 - No immediate concerns to travelling public.

| Structure No. | Feature | Feature | Inspection | Overall | Current | Recommended | Recommended Repairs |
|---|---|---|---|---|---|---|--|
| 06-170-149 | Medary Ave. (Co. Hwy. 77) | Sixmile Creek | 9/2/2025 | 5 | Not Posted | No Load Posting Required | 1. Monitor bridge concrete overlay delaminations. Consider planning for future replacement of low slump dense concrete bridge deck overlay (within next 3-5 years). 2. Repair and/or replace damaged guardrail sections, timber posts, and timber blocking. Consider complete NW & SE approach guardrail replacement with flared or tangent end terminals. 3. Repair broken welds on steel bridge railing post-to-rail connection. 4. Clean & Repaint steel bridge railing. 5. Clean and repair spalling with exposed rebar at deck drain locations on underside of concrete slab. 6. Repair undermining at south abutment backwall and install Type B drainage fabric and quartzite riprap along north and south berms and backwalls. 7. Remove trees under and around north and south spans on east and west side of the structure. 8. Monitor scour under west end of structure and in downstream channel. |
